WELDING INSPECTION REPORT

Resident Engineer: Casey, William **Report No:** WIR-027671 Address: 333 Burma Road **Date Inspected:** 31-May-2012

Project Name: SAS Superstructure **OSM Arrival Time:** 700 **OSM Departure Time:** 1730 **Prime Contractor:** American Bridge/Fluor Enterprises, a JV Contractor: American Bridge/Fluor Enterprises, a JV **Location:** Job Site

34-0006 **Bridge No: Component: SAS** Tower

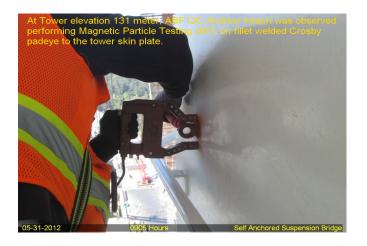
At Tower elevation 131 and 123 meter, QA randomly observed ABF/JV qualified Jeremy Dolman perform all position Shielded Metal Arc Welding (SMAW) fillet welding Crosby size number 4 padeye on tower skin plates. There were two padeyes being welded on tower skin plates A and E on tower shafts South and East while there are two only welded padeyes on tower skin plate A of tower shaft North and West. The padeyes are also being welded per Contract Change Order (CCO) #201 and per Caltrans approved drawing Tower Access Detail #30.
